Clearance Inspection Checklist	
Job Number	16725
Project Name	DC Multiple Projects
Project Address:	930 Tacoma Ave South
Project area in facility:	925 building, East Bathrooms
Client:	Pierce County Facilities Management
Client Job Number:	
Visual	
Visual Date and Time	30-Oct-2019 08:00
Area Cleaned & Wet Wiped?	Yes
Removal surfaces clean?	Yes
First layer of floor removed?	Yes
Lock down tinted?	Yes
Containment encapsulated?	Yes
Hard to reach/see areas inspected?	Yes
Repeat clean if Necessary	No
Visual Notes/Comments	All exposed flooring tile has been abated from the scope of work.
Technician conducting visual:	Tyler Sadler
Technician signature

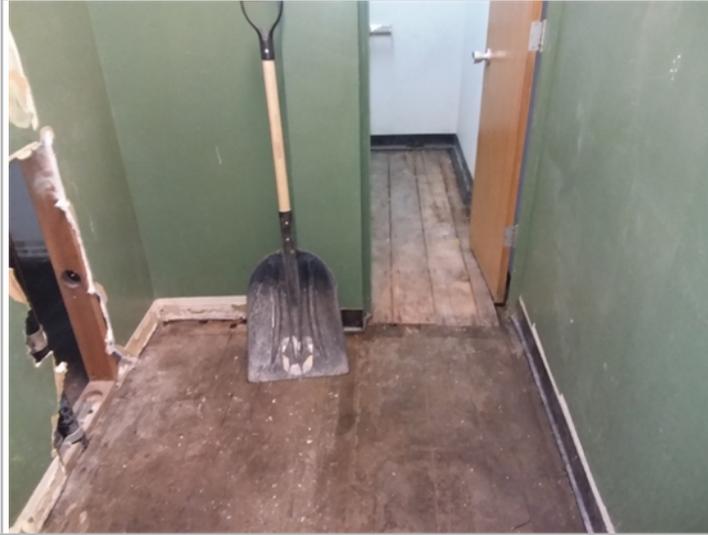
Area Photo:

Air Clearance	
Air Clearance -- Date and Time	30-Oct-2019 10:45
Clearance Air Sample Number(s):	1030-03
Clearance Air Sample Result(s) (Fibers/cc):	F/CC=<0.004
Encapsulant applied and dry before air sampling?	No
Elapsed time since encapsulation:	60 minutes
Clearance below specified level?	Pass
